# Manhole Inspection Summary

Manhole # S21I1\_016MH

Insp Date: **4/13/08 3:24 PM**

**Location** Address: **2918 hollins ferry rd**

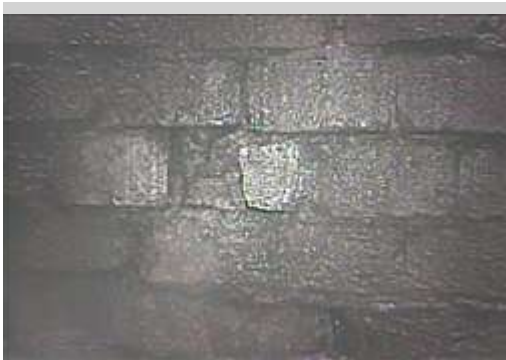
Defect 3

Condition: ☐ Sound ☒ **Cracked** ☐ Root Intrusion ☐ Loose Brick ☐ Deteriorated

Infiltration: ☐ None ☐ Joint ☐ Cracks ☐ Mortar ☐ Roots ☒ **Wall**

cracked barrel brick, infiltration @ barrel wall

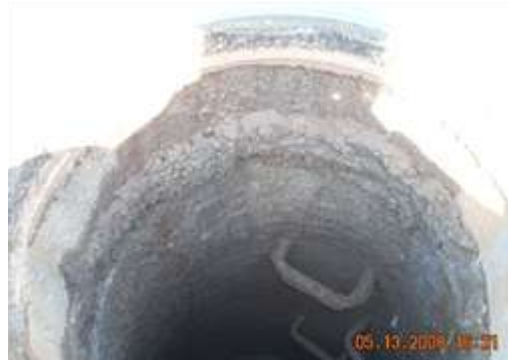
Defect 2

Infiltration: ☐ None ☒ **Joint** ☐ Cracks ☐ Mortar ☐ Roots ☐ Wall

inflow evidence, infiltration @ chimney/frame joint

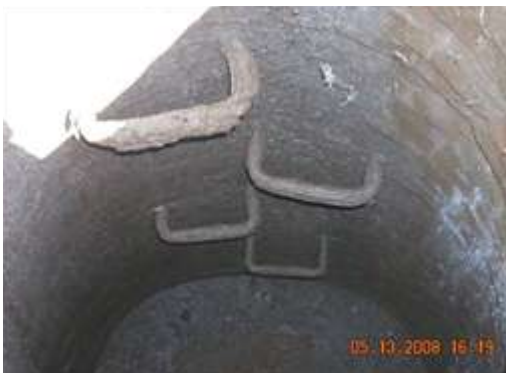
Defect 1

**Steps** Count: **4** Missing: **0** ☒ **Corroded**

corroded steps

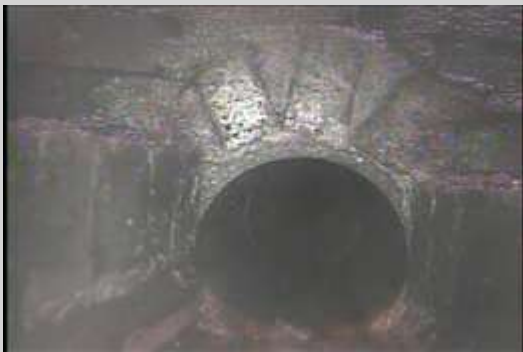
12 O'Clock Outflow

8 in. Circular Gravity Sewer  
Pipe Out @ 12 O'Clock

Pipe Height: **8.4** (in.) Rod and Bar (Angled)  
Pipe Material: **Clay** ☐ Pipe Lined  
Invert Depth: **9.30** (ft.) Flow Characteristics: **Slow**  
Deposits: ☒ None ☐ Mud ☐ Sludge ☐ Debris ☐ Grease  
Silt Depth: **0** (in.) Deposits Extent:  
Infiltration: **None** Pipe Seal Cond: **Sound**

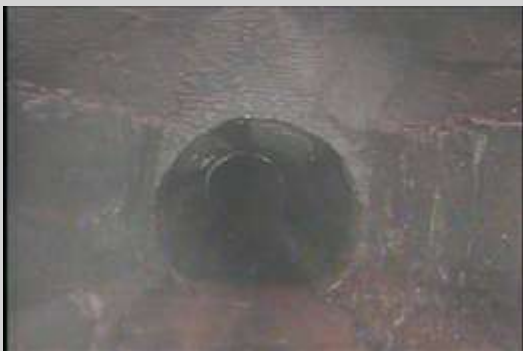
6 O'Clock Inflow

8 in. Circular Gravity Sewer  
Pipe In @ 6 O'Clock

Pipe Height: **8.4** (in.) Rod and Bar (Angled)  
Pipe Material: **Clay** ☐ Pipe Lined  
Invert Depth: **9.19** (ft.) Flow Characteristics: **Slow**  
Deposits: ☒ None ☐ Mud ☐ Sludge ☐ Debris ☐ Grease  
Silt Depth: **0** (in.) Deposits Extent:  
Infiltration: **None** Pipe Seal Cond: **Sound**
